## **PENTRIDGE**

## CONSERVATION MANAGEMENT PLAN

#### H M PRISON PENTRIDGE

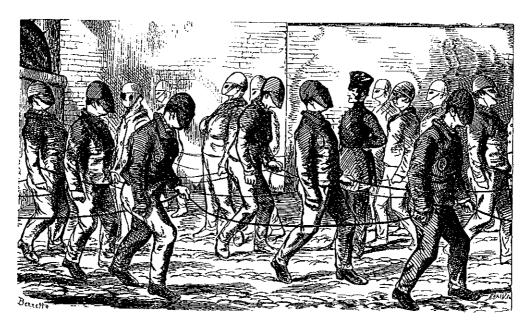
Figure 5 Exercise yard at Pentonville. Reproduced from The Oxford History of the Prison.

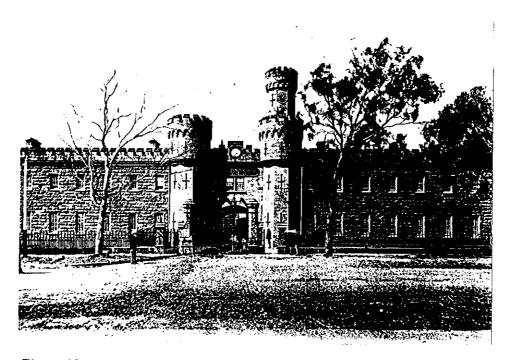
Figure 13 An early view of the entrance building from Sydney Road, following the addition of the clock tower. Courtesy J Armstrong.

entrance building was originally constructed without its clock tower (Fig. 12). This tower, which was not part of the original design, was added to the building within a few years.

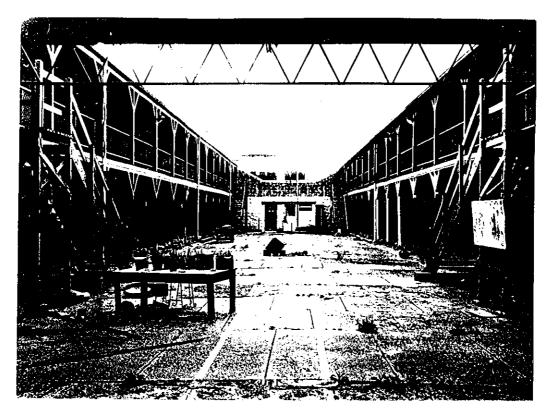
Figure 18 C Division cell blocks. Courtesy J Armstrong.

£10,529/2/6,<sup>116</sup> and the second by another Melbourne contractor, Robert Huckson, at a price of £4,611. These cell blocks were known as B Division until 1890, after which they were referred to as C Division (Fig. 18). C Division was demolished in 1974.

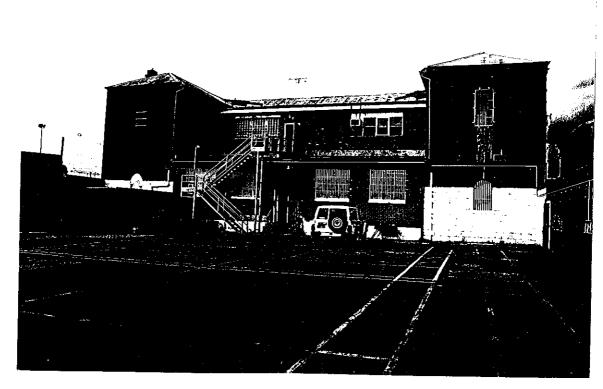
Figure 54 Former Hospital—north elevation, showing the 1940s extension

The area between the side wings at the rear of the building has been infilled with a two storey red brick skillion-roofed structure, flush with the ends of the side wings at ground floor level and set back at first floor level. The original two level timber verandah around the three sides of the area appears to have been replaced in c. 1942–3 with a first floor balcony ward, supported on brick piers. The 1942 drawing shows the balcony as being enclosed with

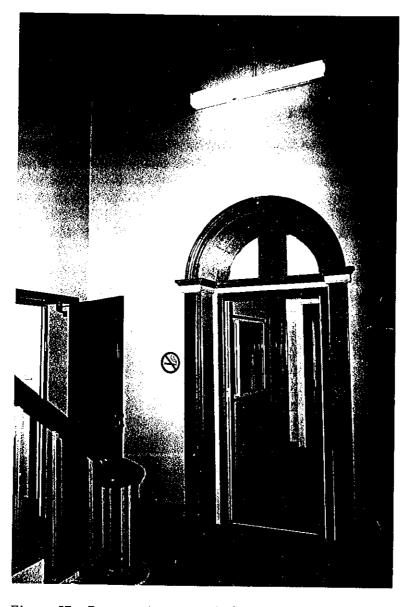
Figure 57 Doorway in rear wall of entrance vestibule, showing original joinery

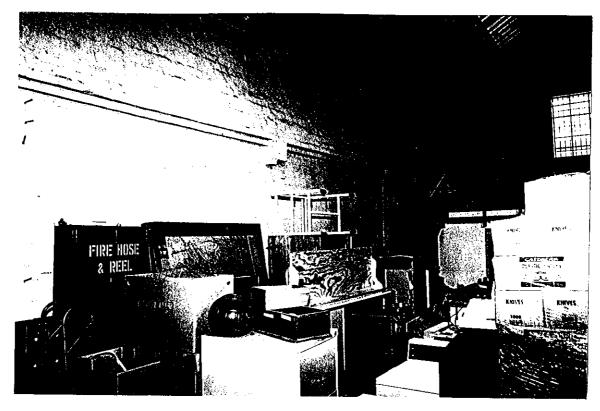
Figure 63 Interior of the centre building, showing the surviving original wall of the east building

The interior of the centre building, originally a single space, now contain a mezzanine level constructed recently on the south and west sides of the space and toilets and office enclosures at the north and south ends. The original brick walls of the east and west buildings, now painted, are exposed internally (Fig. 63).

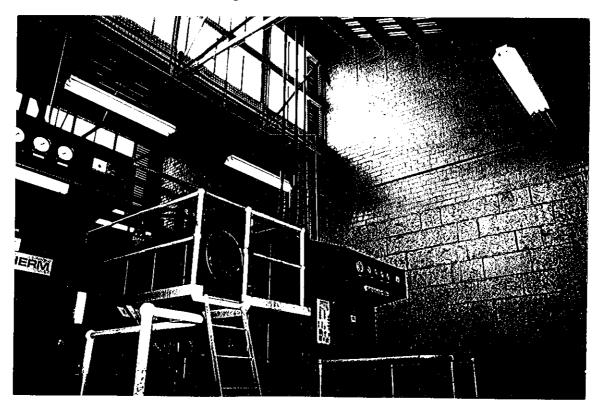
Figure 65 Interior view of Boiler House, showing original bluestone wall to B Division exercise yard

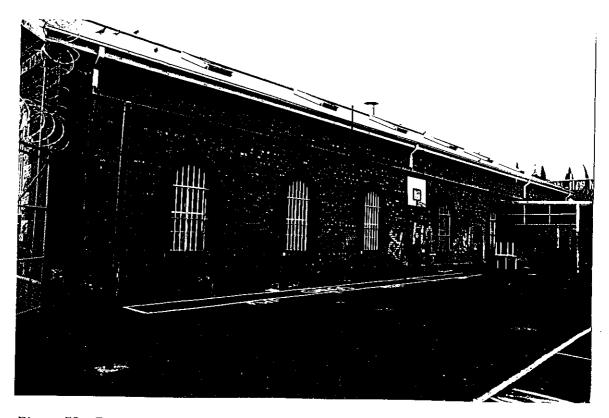
Figure 79 Former kitchen (B Annexe)—west elevation

The west elevation of the original building is of brick construction with a rock faced bluestone ashlar plinth and corner quoins at the north and south ends (Fig. 79). The round-headed window openings have rock-faced bluestone jamb quoins, voussoirs and keystones with drafted margins, original external bars and recent aluminium-framed windows. Some of the bluestone window sills appear to have been replaced. The projecting eaves have recent timber fascia boards and quad profile gutters. A recent door opening, with a sliding door and steel barred gate, has been formed in the elevation. Attached to the elevation is a recent timber-framed skillion shelter, roofed with corrugated steel and polycarbonate.

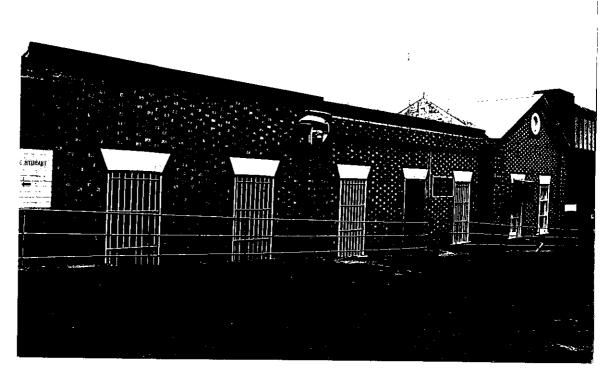
Figure 80 South elevation of the former Woollen Mill, showing the south bay with demolished gable

The principal elevation, facing south, has three bays, and originally was symmetrical with outer gabled pavilions flanking the slightly recessed central bay (Fig. 80). The gable on the west bay has been demolished and the pitched roofs on this bay and the central bay have been replaced with flat roofs. The elevation is constructed with Flemish bond face brickwork with a decorative pattern of alternating red stretcher bricks and cream headers. The outer bays have comer pilasters. On the surviving east gable, the corner pilasters are continued upwards with stepped corbelled brickwork following the slope of the roof. The gable contains a circular opening, now filled with a painted rock-faced bluestone surround. The original ogee profile gable fascia boards have been replaced. 18 The central bay has a horizontal corbelled-out eaves band. The window openings have gauged brick flat arches and bluestone sills, now painted. The windows to the east gabled bay have four-paned lower sashes and two-paned bottom hinged top hopper lights, and appear to be original. The remaining windows have been replaced with aluminium-framed windows and the central window has been altered to form a door. The iron window bars appear to be original. In front of the elevation is a bluestone retaining wall, and a reinforced concrete bridge has been constructed between the wall and the recent door.

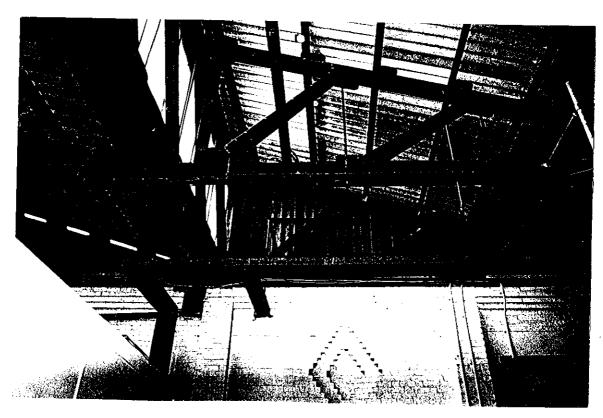
Figure 81 East elevation of the former Woollen Mill, within Building 29

The east elevation, within Building 29, also has regularly spaced piers and a corbelled eaves band (Fig. 81). The elevation, originally patterned Flemish bond brickwork matching the south elevation, is painted. The original central door opening has rusticated bluestone jambs and massive splayed voussoirs forming a flat door head. The original double doors have been replaced with steel doors. There are two window openings, now boarded up, and a bricked up door opening at the south. To the north are several bricked up wide former door openings with concrete lintels, probably formed in c. 1943–4 when Building 29 was constructed, and replacing the original paired window openings matching those on the west elevation. Above the two original doors are diamond-shaped stepped decorative recesses in the brickwork. 19

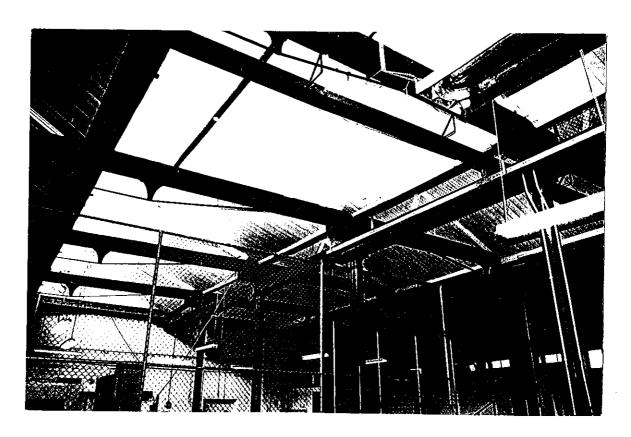
Figure 83 Saw-tooth roof of main workshop area, showing trussed timber and iron beams and iron columns (Building 28).

The roof is supported on built-up transverse timber beams spanning from the east and west walls to a central lateral beam supported on cast iron columns with moulded Doric capitals (Fig 83). The transverse beams are supported at the walls on vertical and diagonal struts bearing onto shaped stone corbels and on timber bolsters above the columns, and are braced with iron rods supported on cast iron stirrups bolted to the undersides of the beams. The roof, double-pitched to the outer bays and with two saw-tooth pitches in the centre, has timber trussed framing built off the transverse beams. The underside of the roof is lined with beaded edged boarding. The saw-tooth roofs have west-facing timber framed highlights with later wired glazing. The double-pitched roofs incorporate possibly later rooflights.

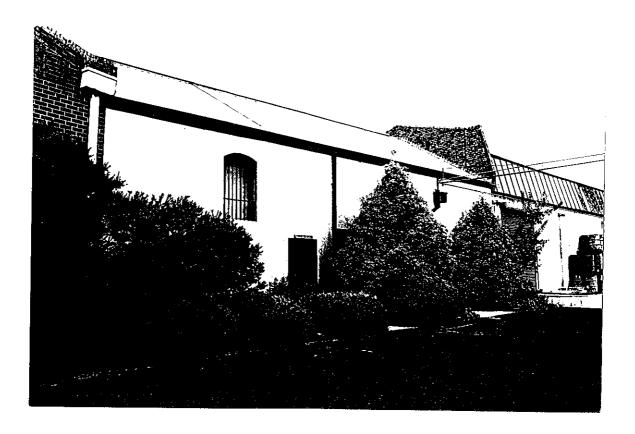
Figure 85 Former Boiler House (Building 30)—east elevation

The former Boiler House, adjoining the former Woollen Mill to the east, is a rectangular gabled brick structure. The only elevation currently exposed externally is the east wall, which has been rendered at a later date (Fig. 85). There are two segmental arched barred window openings in the upper part of the east elevation and two later doors at ground floor level. A third window opening to the north has been bricked up externally, but remains visible internally. These windows appear to have been formed in c. 1881.<sup>22</sup> The flush eaves has a beaded edged fascia board and quad gutter. The roof is covered with recent steel traydeck. The previous brick boiler chimney has been demolished.

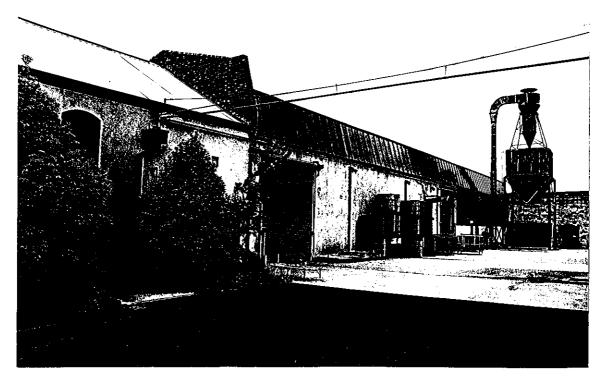
Figure 87 Carpentry Workshop (Building 31)

The original brick east wall of the 1879 building (Fig. 87) has been rendered. Three rendered piers on this section of the wall indicate the location of the walls of a store room and office

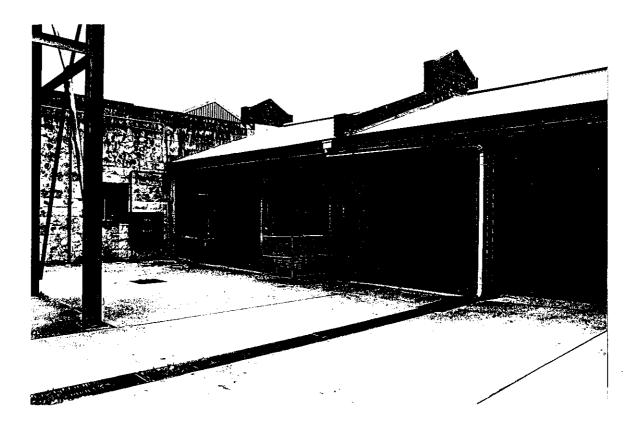
Figure 90 Former Blacksmiths' Shop

The building has red brick walls and a gabled corrugated iron roof (Fig. 90). It is divided into three sections, corresponding to the original functional divisions, by parapet walls rising above the roof.

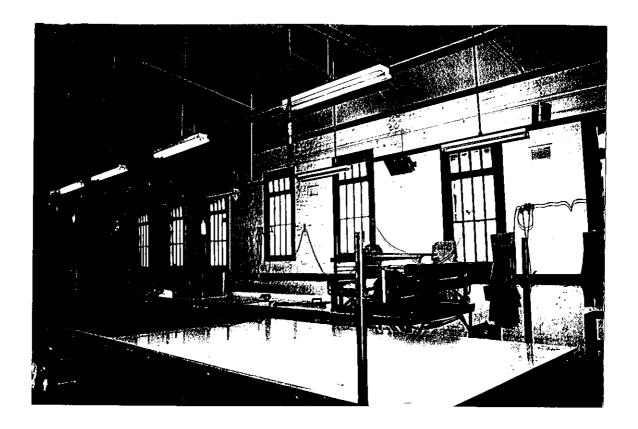
Figure 92 Interior of Tailors' Shop, showing the original windows. The higher windows in the centre indicate the location of the original overseer's room which originally divided the space into two workshops

The interior originally was divided into eight workshop spaces and two overseers' rooms by internal cross walls and lateral walls along the central axis of the building (Fig. 92). An elevated gangway for sentries ran the length of the building above the workshops between the sentry posts at each end. Each workshop contained a fireplace and a latrine. All of the original internal walls and the gangway have been demolished and new internal cross walls have been constructed in the centre of the building, forming two large workshops and an elevated central overseers' room. The date of these alterations is not known, but appears from physical evidence to be possibly the 1920s or '30s. The existing interior has concrete floors, as originally, and painted brick walls. The ceilings are lined with later painted hardboard

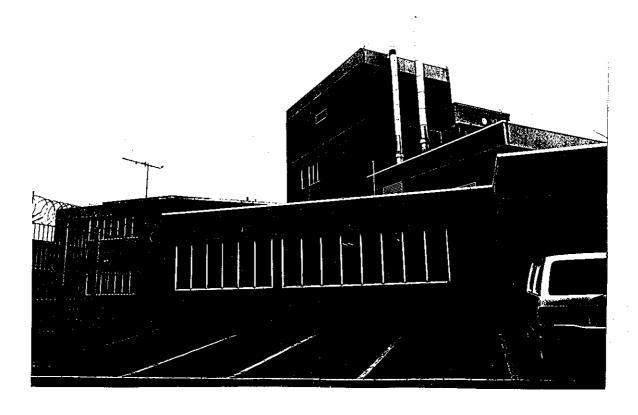
Figure 93 East elevation of the Hospital

The building design is based on two triangular blocks, two storey to the south and single storey to the north, linked by a four storey rectangular services tower in the centre (Fig. 93). The sloping building site is enclosed on all sides by nineteenth century bluestone boundary walls. There is a fenced exercise yard at the south-east corner.

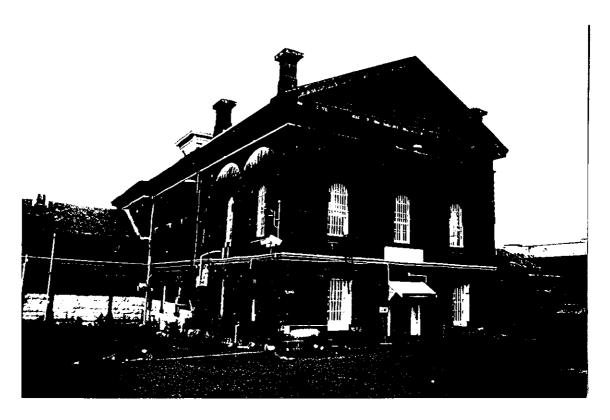
Figure 94 West elevation of the west wing showing the elaborate detailing of the entrance to A Division.

The external walls are constructed from bluestone ashlar which is detailed variously at different levels up the building and in different sections of the building. At the ground floor level of the west wing there is a smooth bluestone plinth above which are five courses of rusticated rock-faced ashlar. (Fig. 94) A smooth projecting string course runs around at ground floor window head height. The wall surface above is pick-faced ashlar which rises to a smooth projecting string course at the springing point of the first floor windows. The wall surface above window head height is similarly detailed up to the moulded cornice. Between the cornices and the moulded eaves, the walls are also pick-faced ashlar and are punctuated with vent openings. They are further articulated by rusticated quoining, rusticated segmented voussoirs to the squared-headed ground floor windows and arched voussoirs to the arched first floor windows which are further embellished with a series of smooth recessed arches. All windows are barred. The gable end on the west elevation is infilled with ashlar and contains a central oculus with moulded bluestone surround.

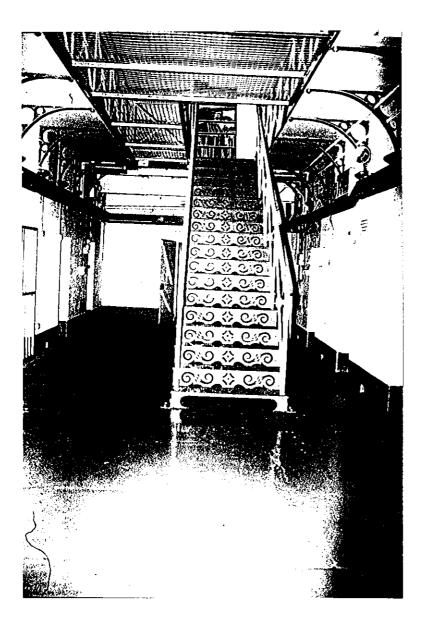
Figure 96 Interior of the cell block showing the main corridor with galleries, typical stair and balustrading above. The entrance to H Division is behind the stair.

The cell blocks are almost identical. A central corrugated galvanised steel barrel vaulted full height corridor runs the length of each wing and provides access to the cells arranged in two tiers behind tuck-pointed, pick-faced bluestone ashlar walls. The ground floor cells are accessed directly from the main corridor while those on the upper level are accessed from galleries. Cast iron stairs at each end of each block lead up to the galleries, which run around the walls. They have cast iron chequer plate floor panels, some of which have been replaced, and are supported on quadrant brackets fixed to the walls and supported by stone corbels. The balustrading to the central void, which is infilled with non-original welded steel-framed wire mesh, is of standard design and has wrought iron handrails supported on square section posts and rectangular diagonal bars with circular diagonal bosses at the central crossing point. (Fig. 96) Beneath the galleries electrical conduit in boxes has been affixed to the walls.

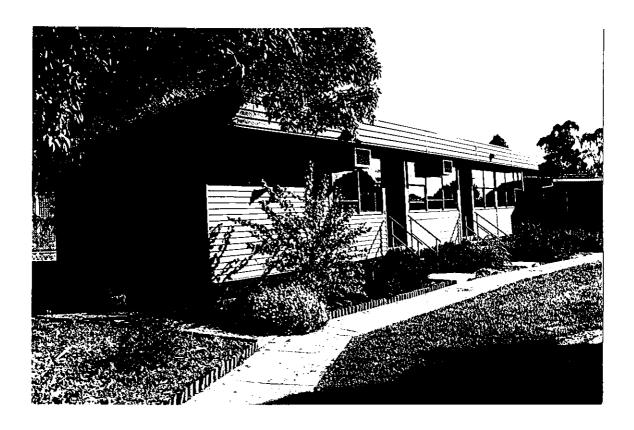
Figure 101 Education complex administration building (Building 47)

Building 47 (Fig. 101) is a standard portable structure raised on a timber boarded plinth with metal weatherboard clad walls, aluminium windows and a metal tray deck skillion roof with a boxed eaves gutter. Steel steps with open risers provides access to two entrances.

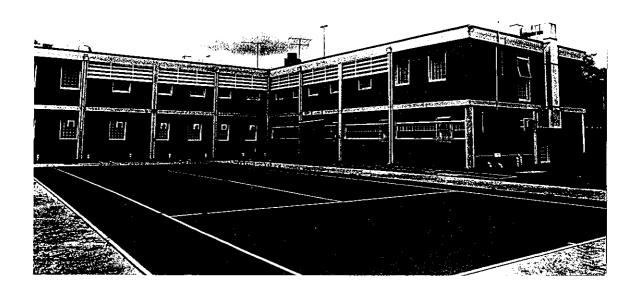
Figure 102 J Division—view from north-east

The building has an exposed column and beam concrete frame with recessed infill wall panels constructed from red brick (Fig. 102). Originally, much of the lower level was open-sided or had more deeply set back walls. All of the lower level walls were rebuilt as part of the 1986–7 conversion of this level to additional cells. The flat roof is covered with a built-up membrane system. Air handling plant and ducting is mounted on the roof. On the east side of the south wing is a partly glazed brick stair enclosure, constructed in 1986–7, linking the two levels and providing an additional entrance to the building. A brick and concrete ramp, constructed at the same time and replacing the original steps, rises to the original upper level main entrance on the south elevation of the south wing.

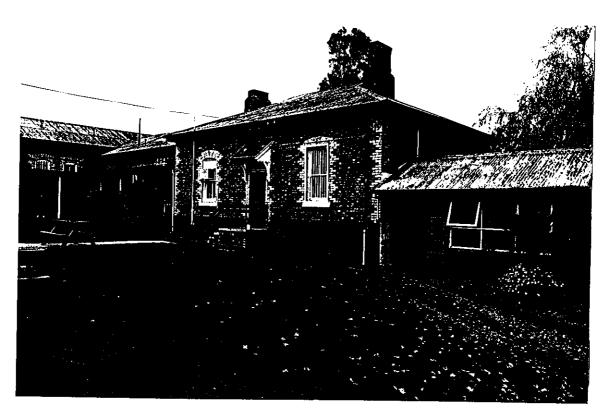
Figure 110 G Division—south wing

Figure 111 G Division—centre wing

Figure 112 G Division—north wing

The original 1875 reformatory building is a single storey building and has a symmetrical U-shaped plan form with projecting north and south side wings enclosing a lawned garden area in front of a slightly higher central wing (Figs. 110, 111 and 112). The end sections of the north and south wings and the central section of the centre wing form distinct pavilions projecting in front of the linking corner sections. The building is constructed from tuck-pointed red brick on a bluestone rock-faced ashlar plinth. The painted corrugated steel roof is hipped, except for gables at the north and south ends of the centre wing, and has small gablets above the pavilions. The chimneys, apparently altered, have rendered surfaces, with stepped plinths and plain rectangular caps.

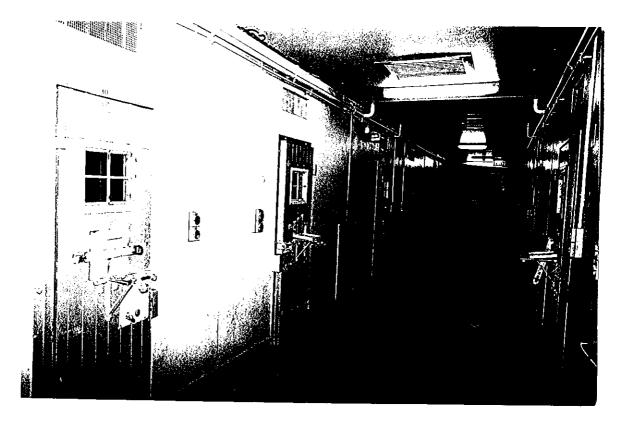
Figure 118 Interior of the 1959 cell block, showing the rehung original doors in the north section of the west wing

The 1956–8 cell block is divided into two separate units located in the west and south wings respectively, both with cells opening onto a central corridor which runs the full length of each wing. Each wing also contains showers opening off the corridors. The concrete floors are lined with sheet vinyl in the corridors and are painted concrete in the cells. The walls and ceilings in the corridors and cells are painted precast concrete slabs. Each cell contains a stainless steel toilet, an enamelled cast iron wash basin and a loose steel-framed bed. The cell doors in the south wing are of steel construction, outward opening, with flush locks, bottom-hinged opening hatches and observation windows. They appear to be later replacements. The original inward opening cell doors in the west wing are of timber construction, with vertical board facings, and have flush locks and bottom-hinged opening hatches, of a different pattern to the south wing doors, and small observation spyglasses rather than windows. In the north section of the west wing, the original doors have been rehung to open outwards and observation windows have been fitted (Fig. 119).

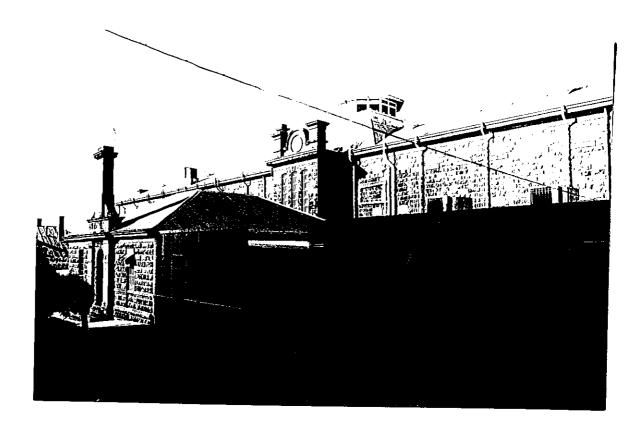
Figure 121 D Division—north elevation, showing entrance wing and central lantern

The three storey main block (Fig. 121) has rock-faced bluestone ashlar walls with a smooth chamfered plinth course at ground floor level and a smooth-faced frieze band and projecting moulded eaves cornice. A tall single-flue chimney serving the ground floor chief warder's room, constructed from smooth-faced ashlar with a moulded cornice, rises from the north elevation on the east side of the central bay. Some of the original tuck-pointing to the stone joints survives. Sections of the lower level of the north elevation on each side of the entrance wing are obscured by the later Buildings 67 and 70.

The hipped roof, originally slated, is covered with galvanised steel and drains to a gutter formed in the top of the stone cornice. Above the central crossing bay is an octagonal timber framed lantern, constructed above a square flat-roofed base. The lantern has square windows with louvred vents above and a pyramidal roof covered with corrugated steel and surmounted by a ball and spike finial. The sides of the square base appear to be clad with corroding painted sheet steel, and the top is covered with relatively recent steel traydeck. On each side of the central bay are continuous rooflights on each side of the ridge. Between the semi-circular pediments on the east and west elevations and the end hips of the main roof are barrel vaulted roofs covered with roll-jointed lead sheet. Header tanks have been installed above the roof and smoke extract fans have been installed recently.

The small cell windows on the north and south elevations have segmental-arched openings with splayed voussoirs, drafted margins to the jambs and arches, and slightly projecting smooth-faced window sills. The windows are fitted with fixed glazing, in two overlapping pieces forming a ventilation slot and original external iron bars. Some of the glazing could be original. Outside the original bars, flush with the outer wall face, are recent expanded steel mesh screens. The warders' rooms on each side of the central bay have similar but slightly larger openings, and are fitted with cast iron frames with original ribbed glazing.

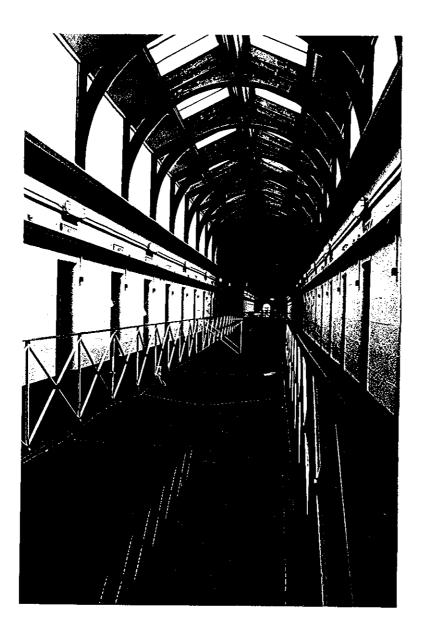
Figure 125 Galleried corridor looking west, showing the iron galleries and the arched timber roof trusses

The full-height central corridor runs the full length of the building and has cast iron galleries on each side at each of the upper levels (Fig. 125). The main stairs are in a projecting wing on the north side of the central crossing axis (Fig. 126), and additional stairs are located at each end of the corridor. On the south side of the crossing is a bay leading to the exercise yards.

The corridor roofs on each side of the crossing are constructed with a series of arched timber trusses above the cornice with continuous rooflights on each side of the ridge. The trusses, rooflight reveals and all of the other exposed ceiling woodwork are constructed from varnished imported softwood. The vertical faces between the trusses above the cornice and the sloping ceilings are lined with small-pitch painted corrugated iron. The east and west bays of the ceiling have flat ceilings at cornice level, lined with small-pitch corrugated iron, above which are arched timber louvred vents connected to the external oculus vents. The ceilings are substantially intact apart from the recent installation of smoke extract vents.

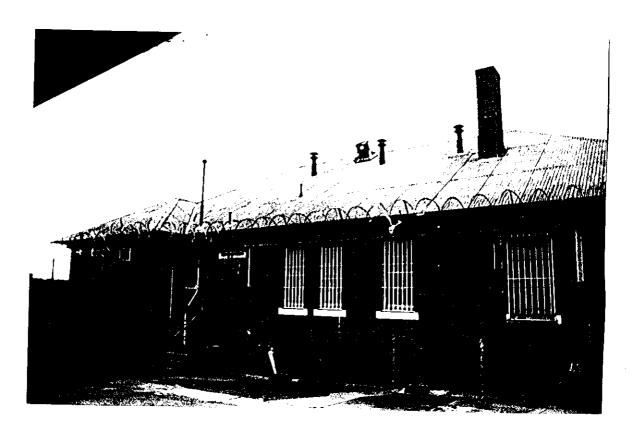
Figure 130 Former Hospital (Building 71)

The former D Dormitories hospital was constructed in the 1920s as part of the establishment of the Metropolitan Prison in 1924. The single-storey building is of English Bond red brick construction with double-hung twelve-paned sash windows and rendered sills (Fig. 130). The windows are barred with steel grilles. The upper part of the walls are rendered. The hipped corrugated iron roof has eaves with exposed rafters.

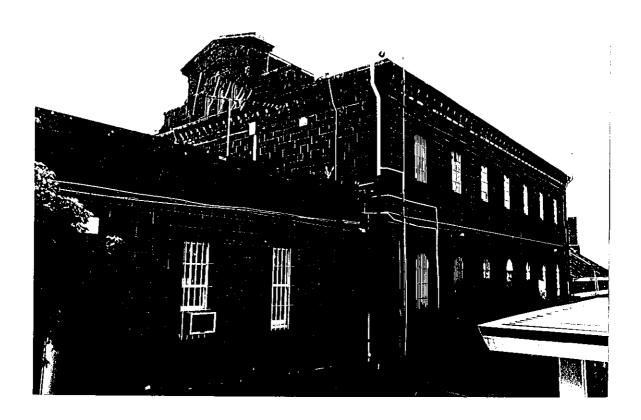
Figure 136 F Division—south elevation

The corners and the jambs to the ground and first floor windows on the north and south elevations have rock-faced quoins with drafted margins. The ground floor window openings are round-headed, and have smooth-faced voussoirs and moulded keystones. Between the windows at arch impost level is a rectangular string course. The first floor window openings have projecting bracketed sills and smooth-faced stilted segmental arches. The windows are fitted with original multi-paned cast iron frames. These originally had small single-pane opening hoppers, now replaced with fixed glazing. At the west end of the north elevation is a round-headed door opening, built up with rendered brickwork. The opening has splayed smooth-faced ashlar jambs and voussoirs. The arch is filled with a original cast-iron multi-paned toplight, with a variety of later glazing. A large heater unit projects from one of the south elevation ground floor windows. Apart from this unit, the built up north elevation door, and later electrical and other services fixed to the walls, the north and south elevations are substantially intact.

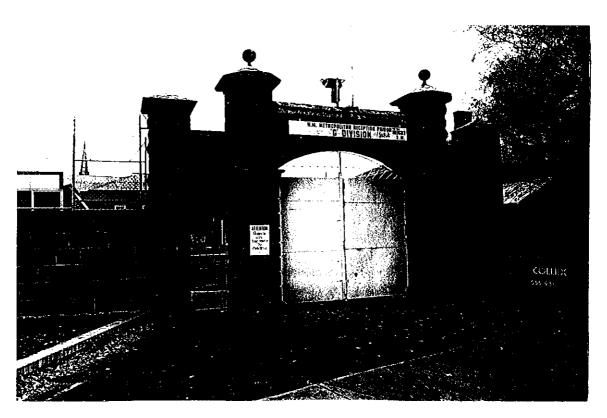
Figure 179 Gateway in Wall Section X

Wall Section X was constructed in 1875 when the Jika Girls' Reformatory was established. Wall Section X is a low wall constructed of coursed rock-faced bluestone. The top five courses of bluestone have been removed along the length of the wall, and is terminated with a flat bluestone coping. At the south end, only one course of the original wall remains. A chain-link fence has been constructed on top of the wall, and part of the wall on the west side has been painted grey. Towards the southern end of the wall, facing the main avenue is a segmental arched vehicular opening with bluestone voussoirs, flanked by smaller pedestrian openings. The original gates have been replaced with have steel gates. The gateway has two octagonal bluestone turrets with decorative bluestone finials. A sign fixed to the gateway reads: "H M Metropolitan Reception Prison G Division" (fig 179).
